HYUNDAI
Technical Service Bulletin

GROUP CAMPAIGN	NUMBER 24-01-051H
DATE JULY 2024	MODEL(S) IONIQ 5 (NE1) IONIQ 6 (CE1)

SUBJECT: VCMS SOFTWARE UPDATE – CHARGING LOGIC
(SERVICE CAMPAIGN 9B5)

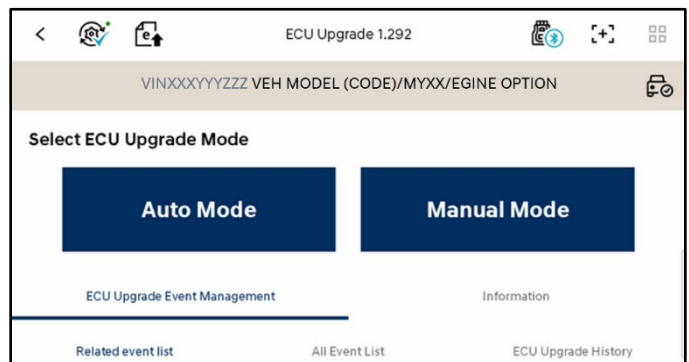
- Select the **VCMS** system to scan the vehicle's current ROM ID.

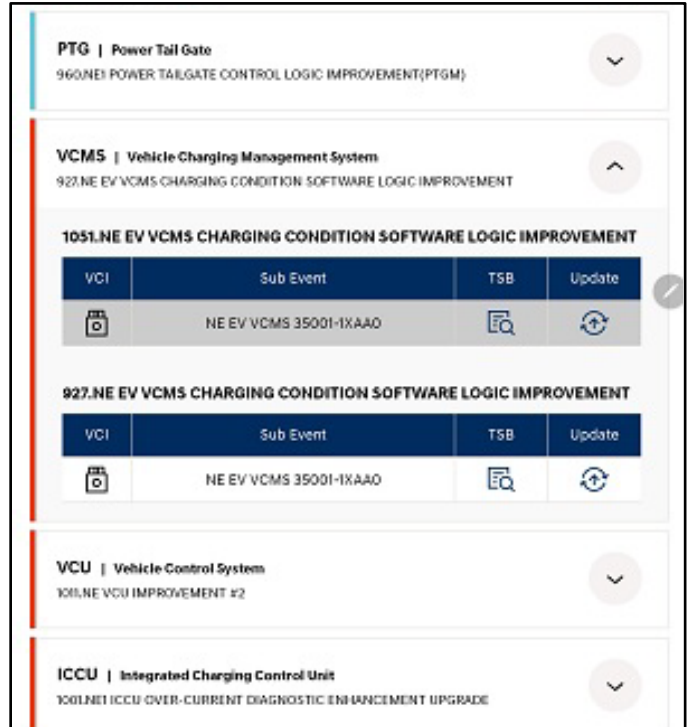
- After the ECU update process shows 100% complete, follow the prompts on the screen to cycle the ignition **OFF** for at least 10 seconds to reset the control unit. (Certain models may take up to 30 seconds.)

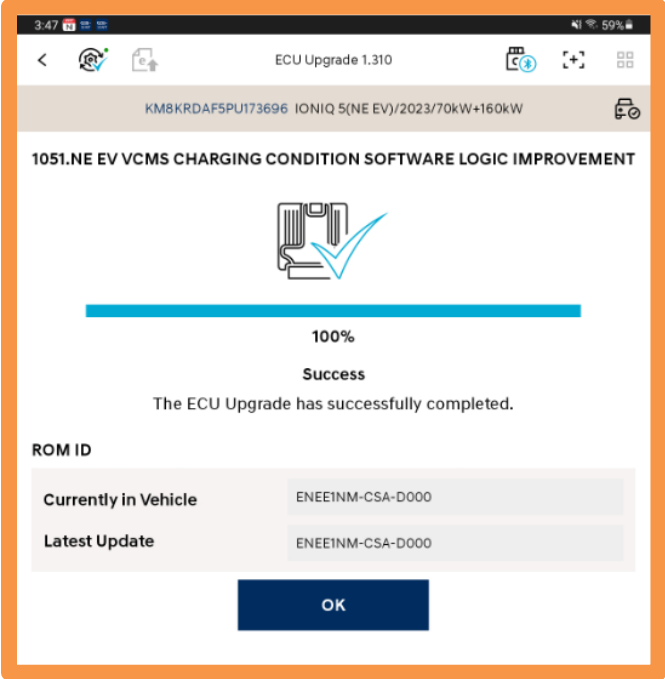
4.

Take a screenshot of the “ECU Update Complete” screen using your tablet and upload to STUI.
